Investigation of an Explosion in a Fume Hood at the Materials Engineering Laboratory

Written by Dr. Menachem Genut, Chemical Safety Officer

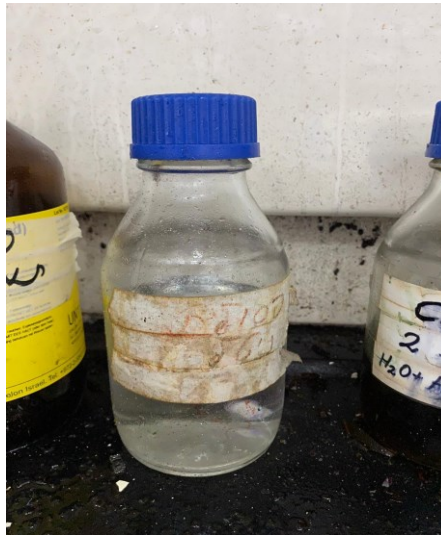
The chemical waste solution into which the NITAL solution was poured contained a mixture that included a large amount of **concentrated nitric acid** (HNO₃).

It is likely that pouring NITAL into the said solution, **in which the concentration of nitric acid was high**, increased the concentration of nitric acid from 3% in the NITAL itself to a level of ~~over~~ more than 10%. It is known that a solution of ethanol and nitric acid becomes explosive if the concentration of nitric acid reaches over 10%! See <https://en.wikipedia.org/wiki/Nital>

Figure no. 1 - The correct waste bottle for NITAL solution was faded and therefore it was difficult to be identified, therefore, the waste was accidentally **put into the wrong bottle**

1. All workers and instructors must pass the “chemical safety training” both by the person in charge in of the laboratory and through the training of the TAU safety unit.
2. There must be clear labeling on all bottles and all waste bottles.
3. It is obligatory to be careful not to close the waste bottles in the fume hood, but to leave them with a funnel only.
4. The fume hood should be lowered as down as possible (up to 20 cm) to protect the employees.
5. All persons that enter the lab: students, instructors, administrative staff, and academic staff, must use personal protective equipment, including: gloves, goggles, lab coat, long pants and closed and sealed shoes. Please, do not allow anyone into the laboratory without appropriate clothing of long pants and closed and waterproof shoes.

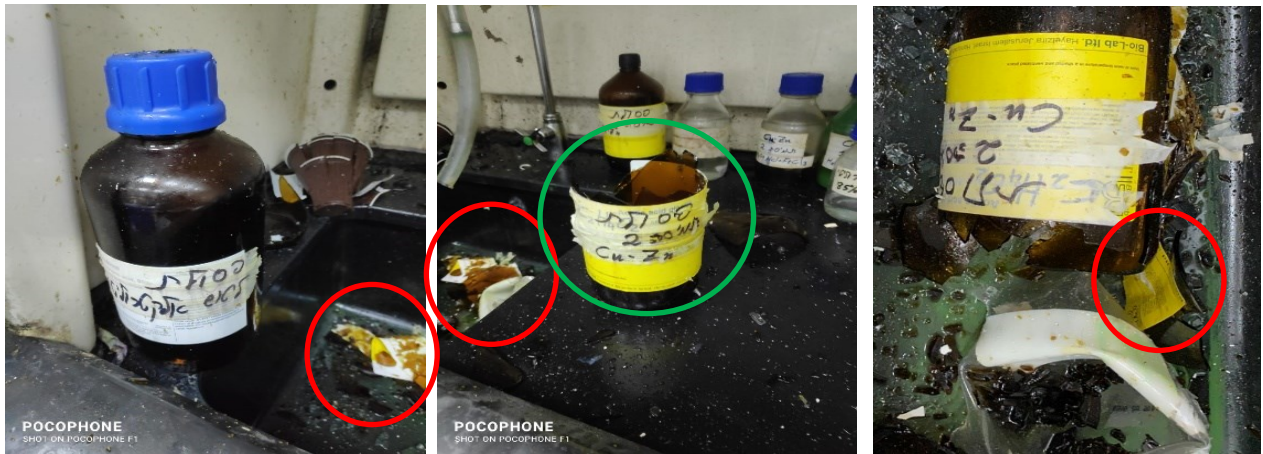
1. Putting waste into the wrong waste bottle that contained a large amount of nitric acid, created an explosive mixture with ethanol when the nitric acid was more than 10%.

2. The explosion was intensified as the waste bottle has been tightly closed with a cork.
3. The stickers on the waste bottles weren't clear and especially the sticker on the correct waste bottle for NITAL was completely faded!

Figure 2. Photos showing the remains of the bottles that were broken during the event.

4. Bottles of chemical waste shouldn't be closed. It is best to leave a funnel in each bottle and not screw a cork. If the bottle had remained open it would not have created a strong explosion but would have released the pressure into the fume hood.
